Manhole Inspection Summary

Manhole # S67Y__015MH

Record Plat: **67Y** Node: **015** Status: **Other (Specify in comment)** Insp Date: **9/1/09 12:41 PM**

Location Address: **BECKLEY ST.**

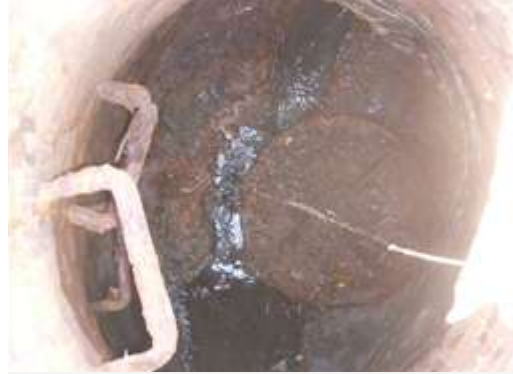
Top View

Comments **NRV2 - HEAVY DEBRIS IN CHANNEL. APPEARS TO BE A MANHOLE COVER FROM A LONG LONG TIME AGO. THIS MANHOLE COVER WAS STUCK CLOSED AND THEN OPENED BY THE CITY.**

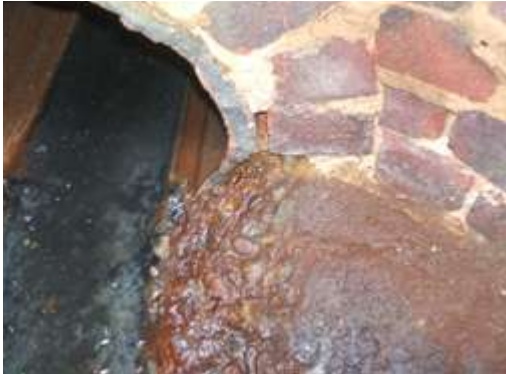
Defect 1

CRACKED PIPE SEAL O12

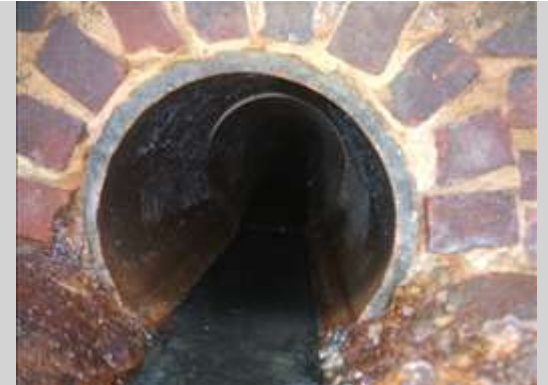
12 O'Clock Outflow

12 in. Circular Gravity Sewer
Pipe Out @ 12 O'Clock

Pipe Height: (in.) Direct
Pipe Material: **Clay** ☐ Pipe Lined
Invert Depth: **7.00** (ft.) Flow Characteristics: **Slow**
Deposits: ☒ None ☐ Mud ☐ **Sludgy** ☐ Debris ☐ Grease
Silt Depth: (in.) Deposits Extent:
Infiltration: **Evidence** Pipe Seal Cond: **Cracked**

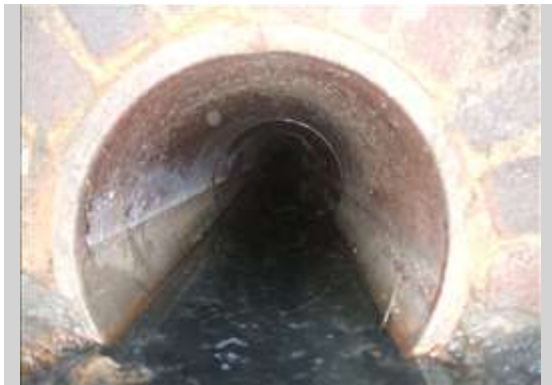
4 O'Clock Inflow

12 in. Circular Gravity Sewer
Pipe In @ 4 O'Clock

Pipe Height: (in.) Direct
Pipe Material: **Clay** ☐ Pipe Lined
Invert Depth: **6.92** (ft.) Flow Characteristics: **Slow**
Deposits: ☐ None ☐ Mud ☒ **Sludgy** ☐ Debris ☐ Grease
Silt Depth: **0.5** (in.) Deposits Extent: **Light**
Infiltration: **None** Pipe Seal Cond: **Sound**
